# **Discovery Place II**

**3970 Carrigan Court, Burnaby, BC**

## **REPORT: Building Envelope Condition Assessment**

Our Reference No. 916-01

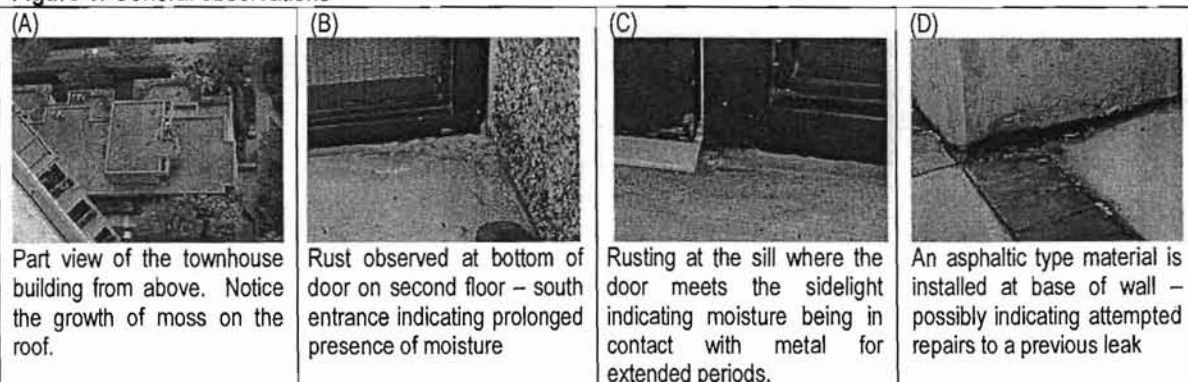
**Figure 1: General observations**

- Observation of rust at second floor south entrance door.
  - An asphaltic material is present in locations at the base of the wall extending above the paved surface. This was only observed at the entrance to the second floor on the south side.

- Prolonged water damage is evident on the wall that runs along the north side of the service way, with the steel channel that lines the outside edge of the "Rock Dash" stucco section heavily rusted.

- There was large amount of moss growth observed in many places on the roof.
  - Some exhaust vents were found clogged or semi-clogged with debris.

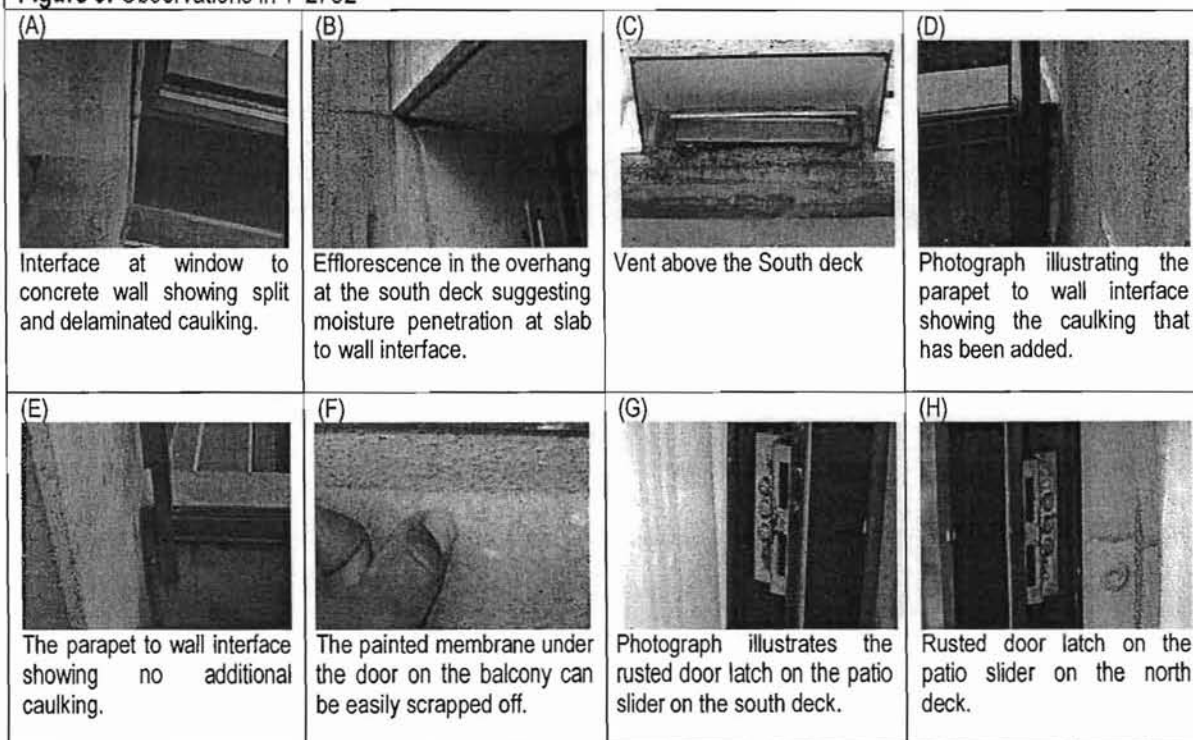
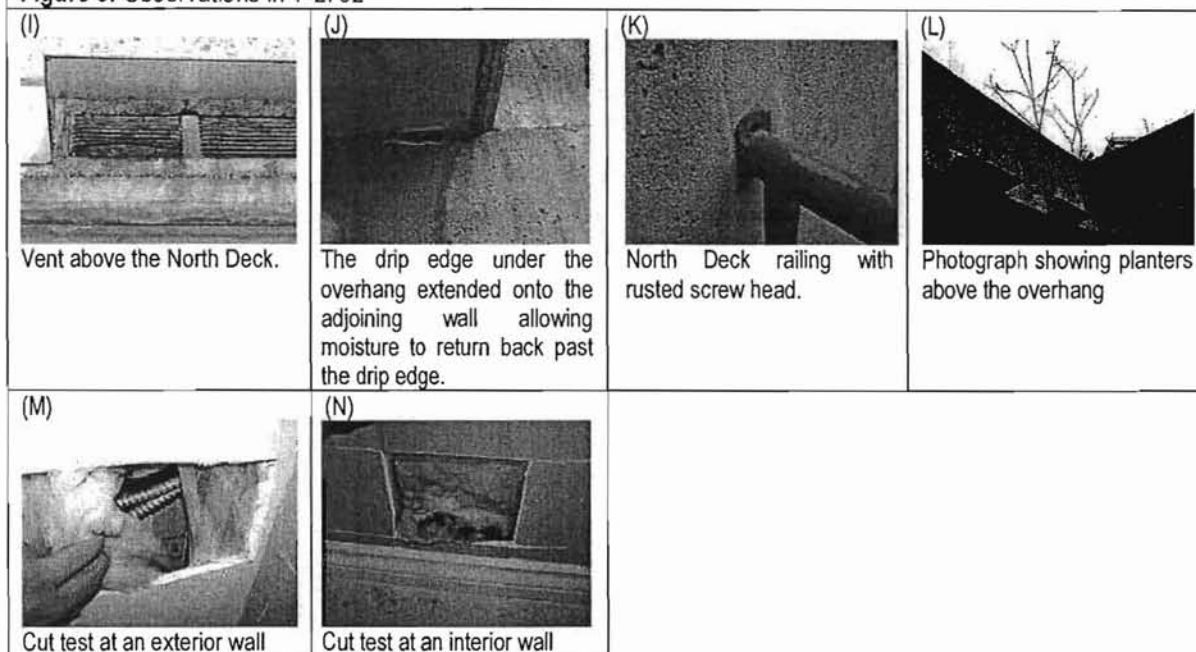
**Figure 3: Observations in T-2702**

- **Townhouse T-2702** : This is a centre unit on the second floor. The following observations were made:
  - Caulking at door and window to wall interfaces as well as between dissimilar cladding materials had deteriorated, which is a common issue observed throughout the development.

- Efflorescence was noticed on the underside of roof overhang to wall interface, which at some locations was very close to the building wall. This indicates moisture penetration from the roof above.

- An exhaust vent at the slab edge was found to contain debris, and another vent was found with a damaged screen.
- The south deck was found to have a caulking seal installed at the interface between the deck parapet and the building wall, whereas the north deck did not have the seal. It appears that caulking may have been installed to address a previous leak.

- The balcony appears to have been painted and this paint in some locations was flaking off.
- The latches on the sliding doors at both balconies were rusted, along with the screws holding the frame in place.

- Cut test through the exterior wall revealed exterior gypsum wall board, batt insulation which had blackened in places where it was in contact with metal studs or metal conduit, polyethylene air/vapour barrier and one layer of interior drywall. Moisture content was around 0.5% in gypsum, which suggests an increased humidity level and therefore susceptible to organic growth.

- Cut test of an interior wall also revealed black staining on batt insulation where it was in contact with the metal stud.

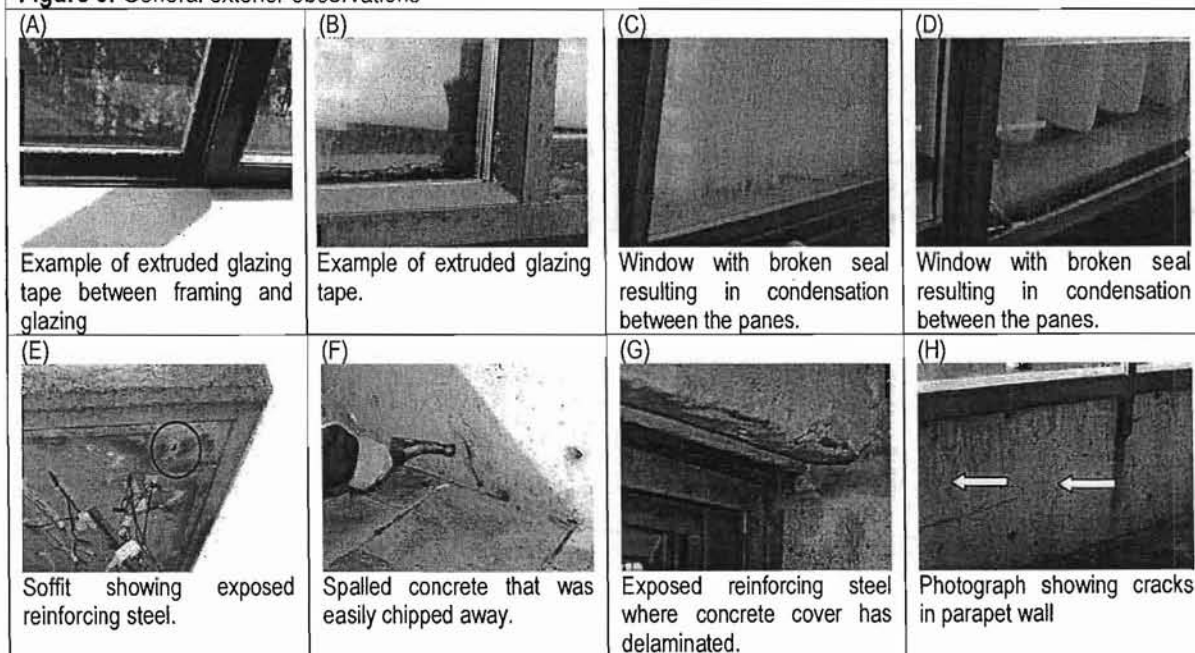
**Figure 5: General exterior observations**

- **Exterior Review :** Three locations were reviewed over the entire height of the building via swing stage and the following observations were made:
  - A common issue noted with all the windows and sliding doors was that the glazing tape installed between the frame and the glazing is extruded or "squeezed out" likely due to repeated cycles of heat and wind-pumping action.

- A systemic issue noted with all windows and sliding doors was the splitting and delaminating caulking installed between window frames and concrete, between metal panels and concrete, around window and sliding door frames, and between stucco and concrete.

- Some of the windows were noticed to have condensation between the panes suggesting a failed seal between the panes.
  - Some windows were noted to have organic matter growing in the sill track which also indicates that the window is subjected to moisture and is being held for extended period of time. This condition can impede drainage of the sill track.

- Caulking installed at the mitred joint of the window frame was found to be delaminating.
  - Fasteners for the metal panels were seen to becoming loose and protruding out in locations. These locations could become potential ingress points for moisture to penetrate behind.

- A common issue noted with cast-in-place concrete was the minor spalling and delamination of the concrete. There were numerous areas noted especially on the soffit of balconies and other overhangs, soffit of stairwells, balcony parapet walls and cast-in-place concrete walls where concrete had delaminated exposing the embedded reinforcing steel.

- Another common observation was the presence of efflorescence (white coloured staining) on most of the soffits of the balconies and overhang edges.
- Cracks have developed at numerous locations in the concrete at parapet walls, curbs, roof parapet wall, and cast in place concrete walls.

- There were cracks, holes and chipped concrete around most of the exhaust vents. Some of the vent screens were damaged and some of the vents were plugged with dryer lint. In some locations, where accessible for review from the swing stage, condensation formation was present along the top of the duct work inside of the vent.

- At slab edge interfaces with adjacent walls, black staining was noticed indicating that water is running to the ends of the flashing and running down the adjacent concrete walls.

- There is a membrane present at the base of the wall that extends from below grade, however, the membrane was delaminated from the wall in locations.
- All of the balcony surfaces consist of an exposed concrete finish with no waterproofing membrane installed. A few owners have painted their balconies and a few have laid an exterior carpet on the floor.

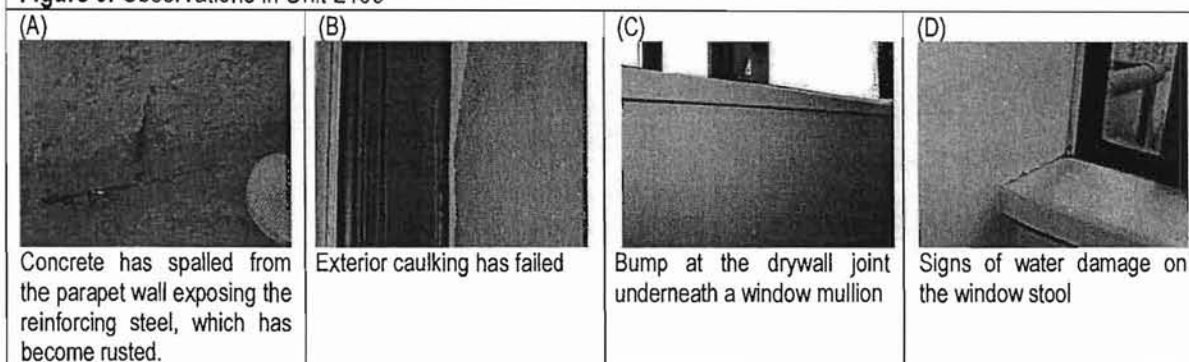
**Figure 6: Observations in Unit 2106**

- **Unit 2106**: The following was observed in the unit:
  - Spalled concrete exposing corroded reinforcing steel.
  - Systemic failure of caulking around windows and doors.
  - There is a bump at the joint in the drywall underneath the mullion of the living room window.
  - Window stool had signs of damage from moisture.
  - Operation of the sliding door is relatively difficult.

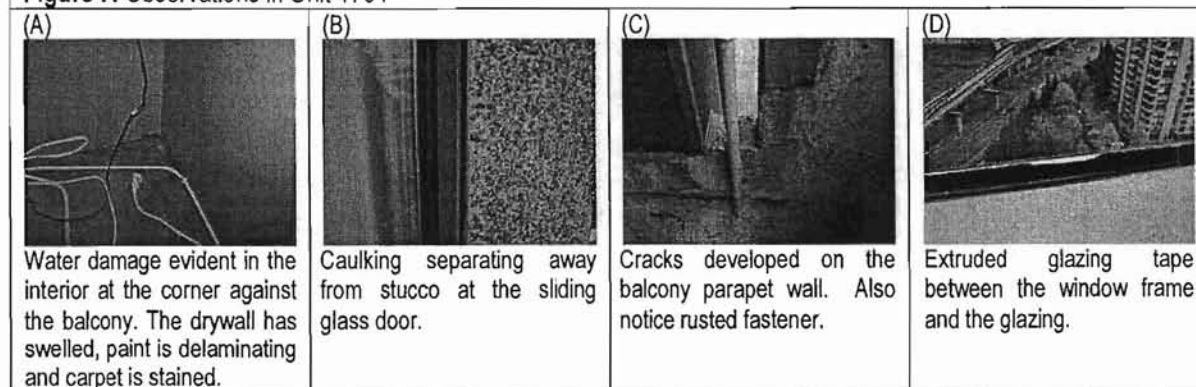
**Figure 7: Observations in Unit 1701**

- **Unit 1701**: The following was observed in the unit:
  - In both bedrooms there is evidence of water infiltration from the exterior. In the inside corners of the bedroom there is damage to the drywall where it has swelled and the paint has begun to delaminate from the wallboard.
  - Observed deteriorated and delaminated caulking throughout.
  - Cracks have developed at the interface of the different height concrete walls.
  - Some of the fasteners were rusted.
  - Observed "squeezing-out" of the glazing tape between the window frame and the glazing.
  - Operation of the sliding door was relatively difficult.

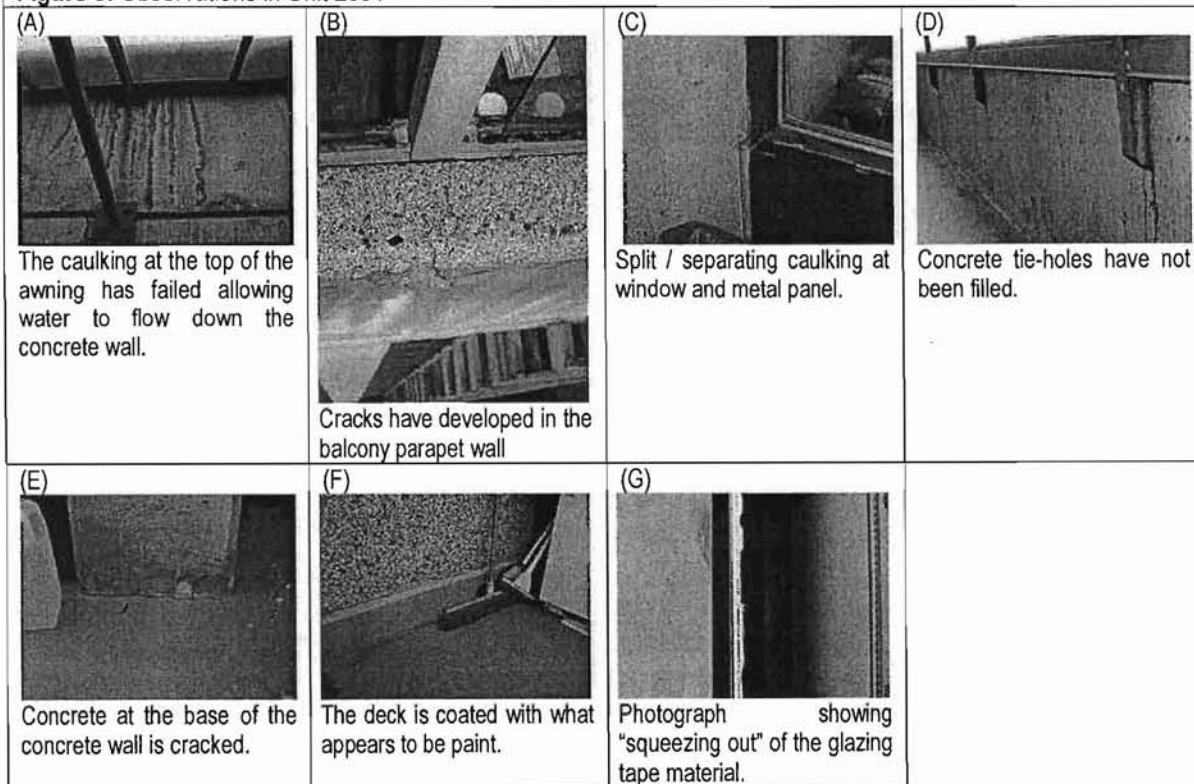
**Figure 8:** Observations in Unit 2604

- **Unit 2604**: The following observations were made in the unit:
  - Water stains are evident on the concrete surfaces underneath the glass skylight awning indicating that the seal between the skylight and the concrete above has failed.
  - The metal structure of the awning itself is rusting, and is further staining the concrete cladding as a result.
  - The parapet walls that the railing attaches to have developed several cracks.
  - The owner indicated that he has previously repaired all spalled concrete areas. It is unclear how the concrete was repaired.
  - Similar to other units, caulking has deteriorated.
  - Glazing tape between the glazing and window frame has squeezed out.
  - Operation of the sliding door is relatively difficult.
  - Base of concrete wall is cracked at the end of the wall.

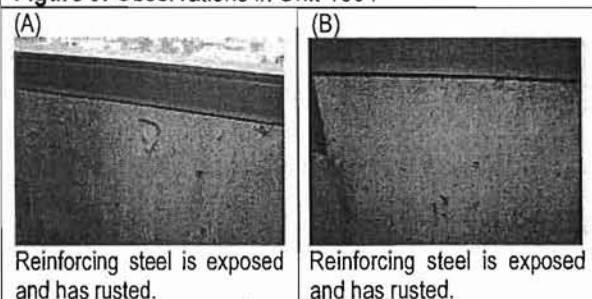
**Figure 9: Observations in Unit 1501**

- **Unit 1501**: The following observations were made in this unit:
  - Systemic failure of the caulking, glazing tape at windows and sliding door, and difficult operation of the sliding door.
  - Exposed reinforcing steel was found on parapet walls at a few locations and the reinforcing steel appeared to be situated close to the surface.
  - There are hollow sounding areas on the parapet wall possibly indicating concrete that has delaminated.
  - Bedroom door has shifted.

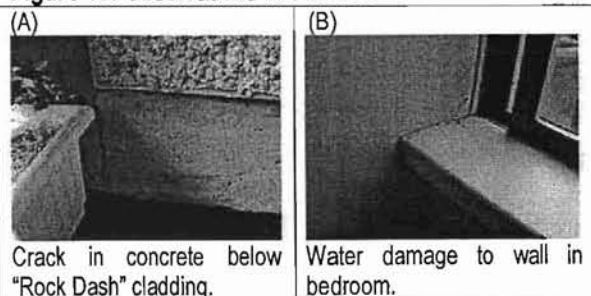
**Figure 10: Observations in Unit 802**

- **Unit 1302**: The following observations were made in this unit:
  - There is a large crack below the "Rock Dash" cladding on the concrete upstand wall.
  - There is evidence of water damage along the window stool in the bedroom.
- **Unit 802**: The following observations were made in this unit:
  - There is a large crack below the "Rock Dash" cladding on the concrete upstand wall.
  - There is evidence of water damage on the window stool in the bedroom.
  - Systemic failure of the caulking, glazing tape at windows and sliding door, and difficult operation of the sliding door.
  - The balcony floor is covered with an exterior grade carpet.

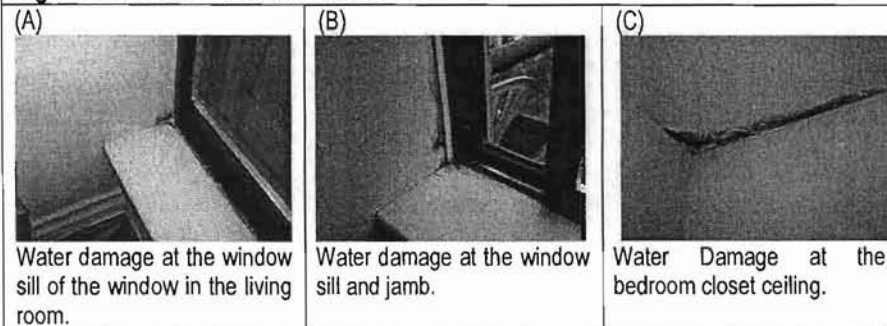
**Figure 11: Observations in Unit 806**

- **Unit 806** : The following observations were made in this unit:
  - There is dark staining due to water damage at both the windows as well as the sliding door.
  - Systemic failure of the caulking, glazing tape at windows and sliding door, and difficult operation of the sliding door.
  - The balcony floor is covered with an exterior grade carpet.
  - The closet in the bedroom also has water damage in the upper corner along the wall.

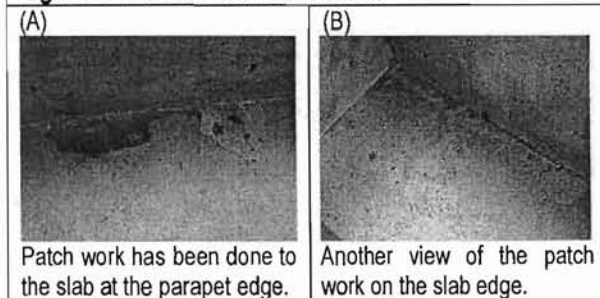
**Figure 12: Observations in Unit 304**

- **Unit 304** : The following observations were made in this unit:
  - Systemic failure of caulking throughout.
  - There appears to have been several patches at the concrete of the balcony slab.
  - The outer edge of the balcony sounds hollow possibly indicating that the concrete surfaces have delaminated.

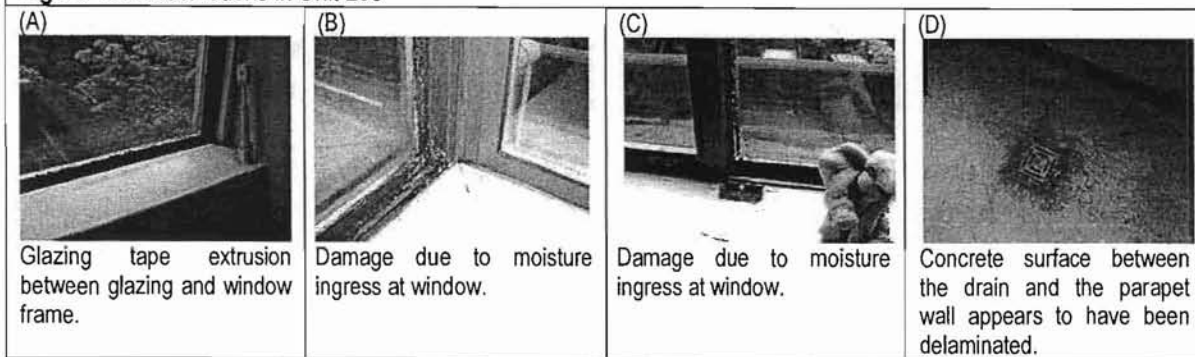
**Figure 13: Observations in Unit 205**

- **Unit 205** : The following observations were made in this unit:
  - Systemic caulking failure throughout.
  - Presence of organic material and evidence of moisture ingress at windows.
  - Extrusion of glazing tape from between the window frame and glazing.

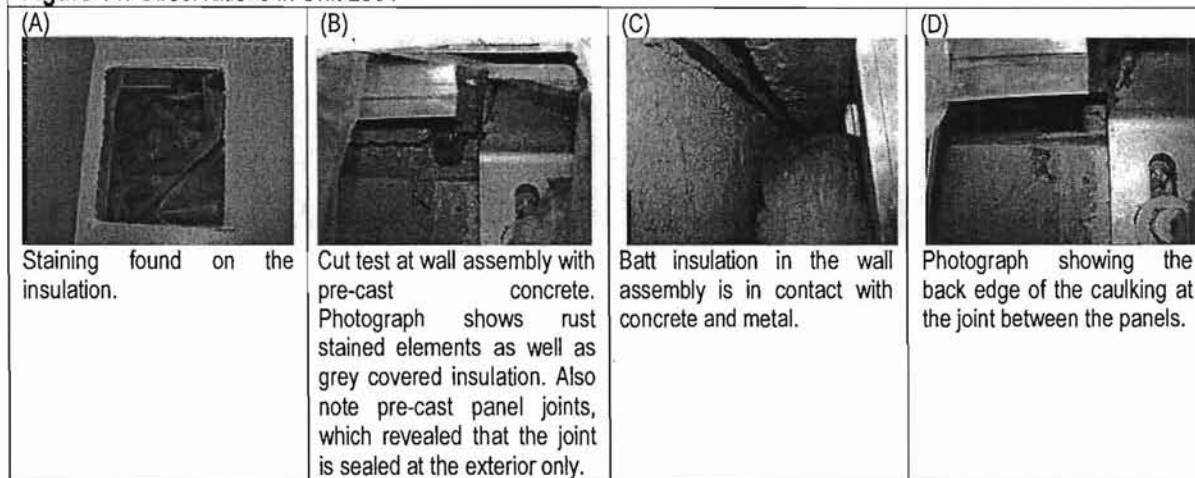
**Figure 14: Observations in Unit 2504**

- **Unit 2504 :** The following observations were made in this unit:
  - Systemic failure of the caulking, glazing tape at windows and sliding door, and difficult operation of the sliding door.
  - A cut test was made in the exterior wall from the interior revealing stained insulation and corroded metal components.

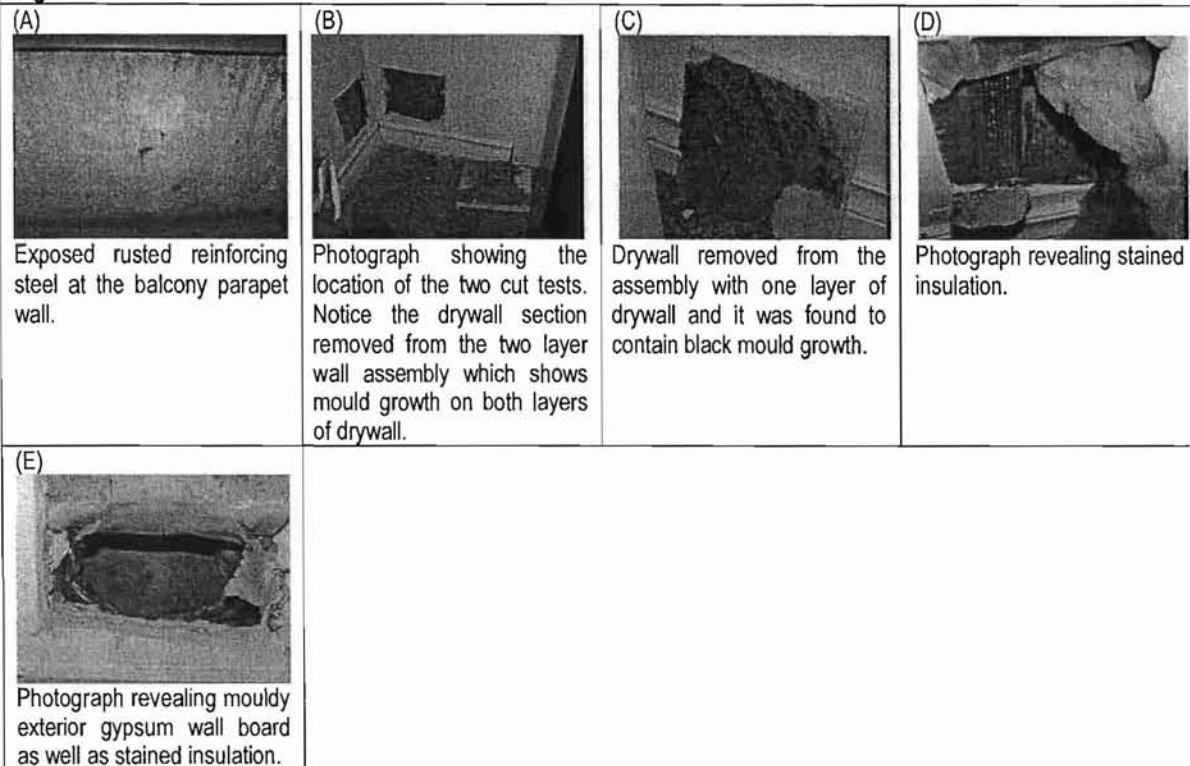
**Figure 15: Observations in Unit 1807**

- **Unit 1807 :** The following observations were made in this unit:
  - Systemic failure of the caulking, glazing tape at windows and sliding door, and difficult operation of the sliding door.
  - Two cut tests were performed on this unit. One of the wall assemblies consisted of one layer of drywall, whereas the other wall assembly consisted of two layers of drywall as seen on Photographs below. Both cut tests showed that the back side of the drywall contained varying degrees of mould/fungal growth.
  - Moisture content testing read approximately 0.1% for inside drywall from the one layer wall assembly, and approximately 0.2% for inner layer of gypsum and approximately 0.4% for the outer layer of the two ply gypsum wall assembly, all of which are within the expected dry range of moisture content.

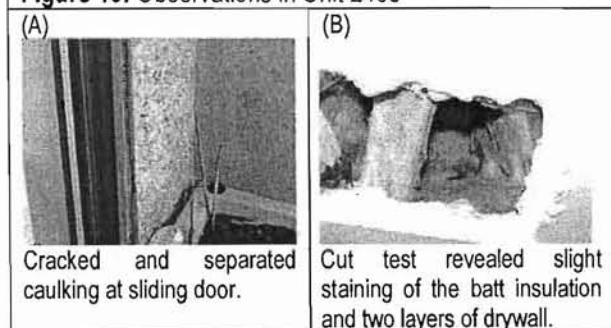
**Figure 16: Observations in Unit 2403**

- **Unit 2403:** The following observations were made in this unit:
  - Systemic failure of the caulking, glazing tape at windows and sliding door, and difficult operation of the sliding door.
  - One cut test was performed on the interior which revealed slight staining of the batt insulation. Moisture content reading of the exterior drywall read approximately 0.3%, which is within acceptable limits.
