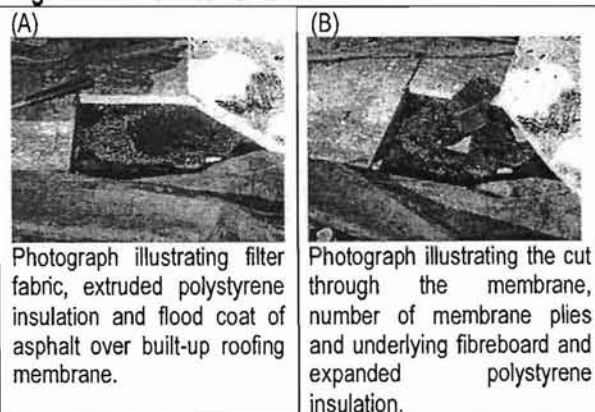
Figure 19: Cut Test Number 1

Comments: Roof system is in good condition at cut location, with no evidence of water penetration or deterioration of components forming roof assembly.

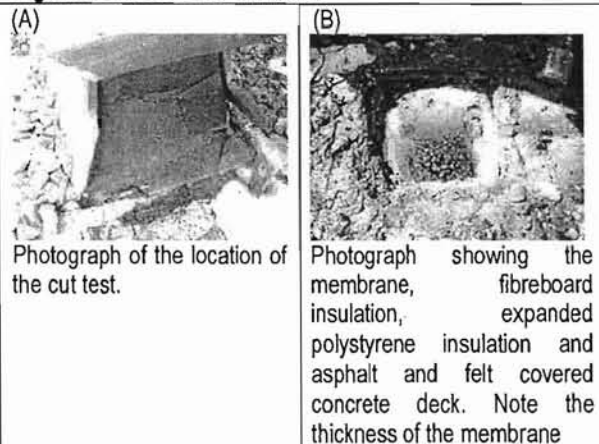
Figure 20: Roof Cut Number 2

Comments: Felt plies of roof system felt damp to the touch. Fibreboard insulation was damp.

1. Replacing split or deteriorated caulking
2. Routing out sealing cracks in the perimeter parapet walls.
3. Remove the organic debris.
4. Redistribute ballast as required to provide uniform coverage.
5. Ensure caulking at mechanical line penetrations through the roof forms proper seal.
6. Consider installing a membrane and cap flashing system along the top of the perimeter parapet walls.
7. Further investigation is required to determine the cause and extent of damp membrane/fibreboard at roof cut numbered 2.
